SAND 80-0808
UNLIMITED DISTRIBUTION

PROTECTIVE COATINGS AND SEALANTS FOR
SOLAR APPLICATIONS

K. B. WISCHMANN
M. H. GONZALES

Sandia National Laboratories

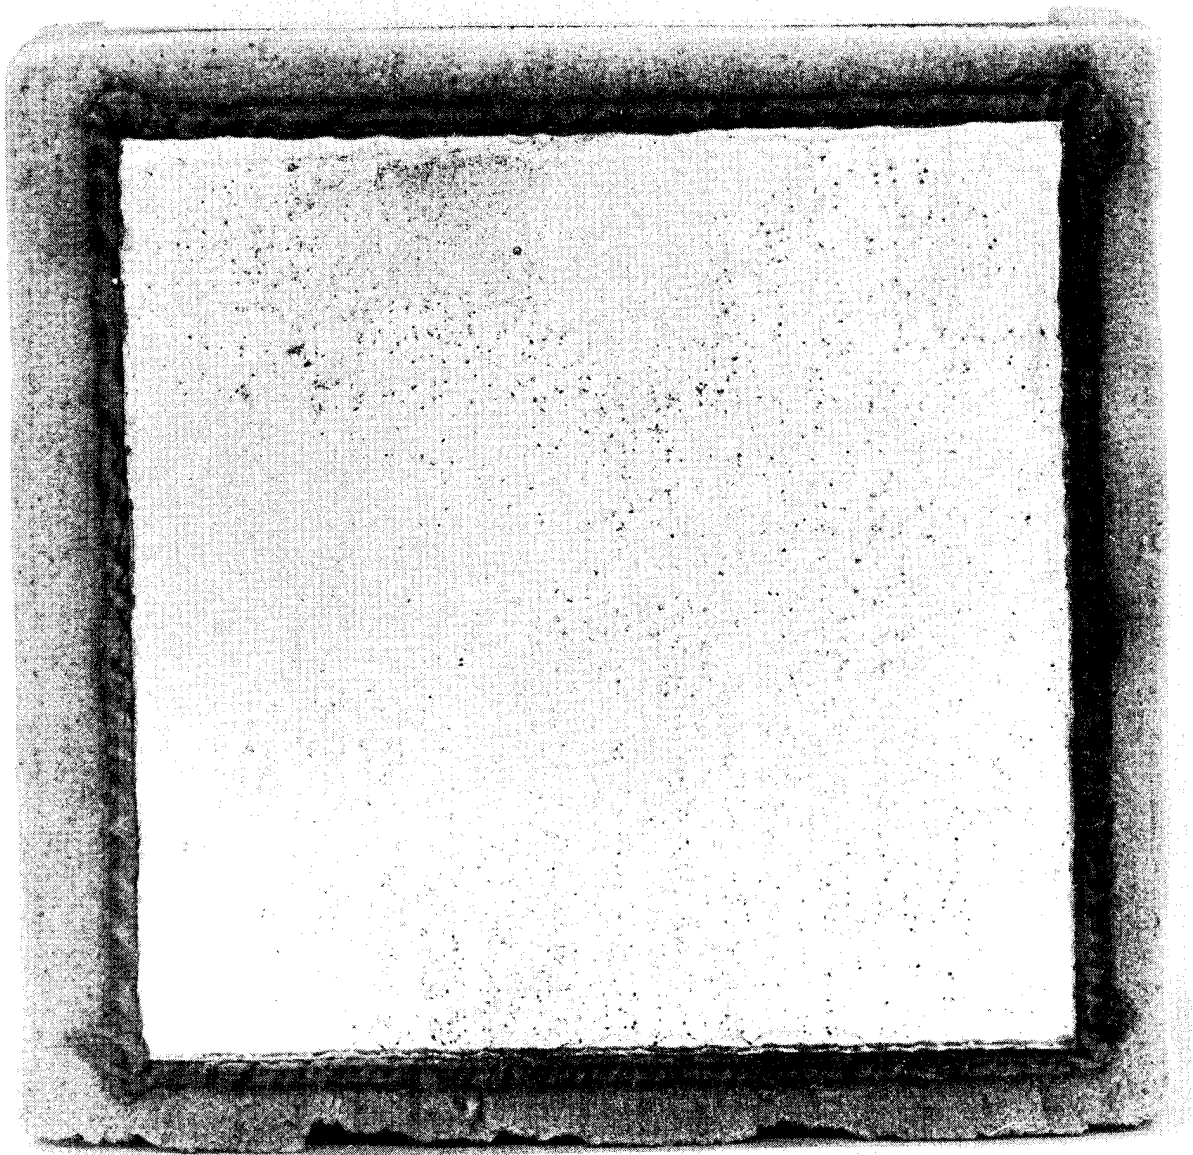
FIGURE 1

POLYSTYRENE FOAM

ADHESIVE : 3M's EC- 3549

EDGE SEAL : DOW CORNING 790 SEALANT

TIME AGED : 12 mos

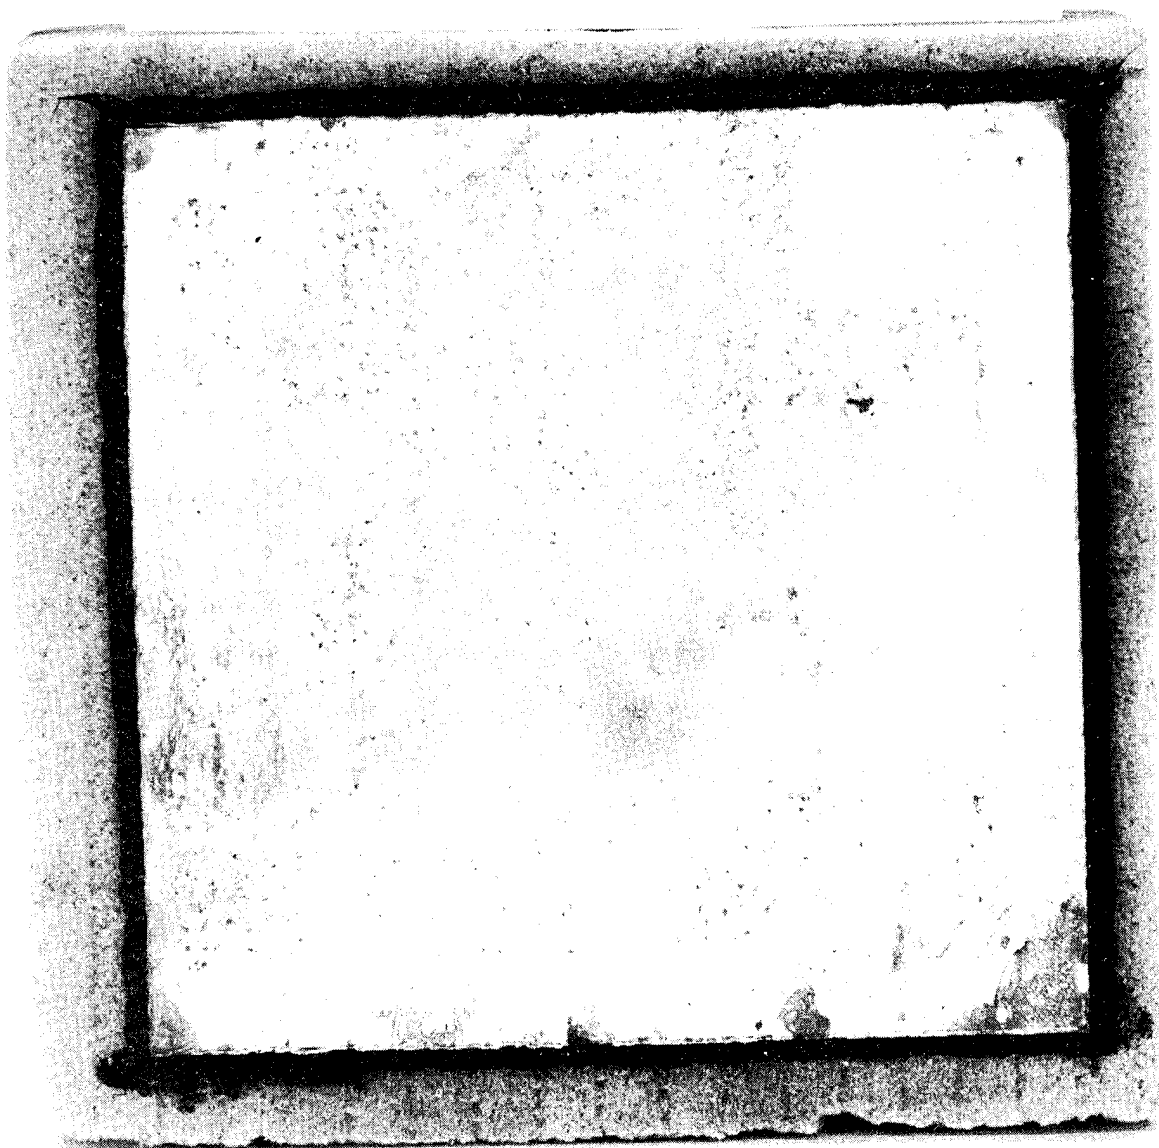
FIGURE 3

POLYSTYRENE FOAM

ADHESIVE : 3M's EC- 3549

EDGE SEAL : GE 1200 CONSTRUCTION SEALANT

TIME AGED : 12 mos.

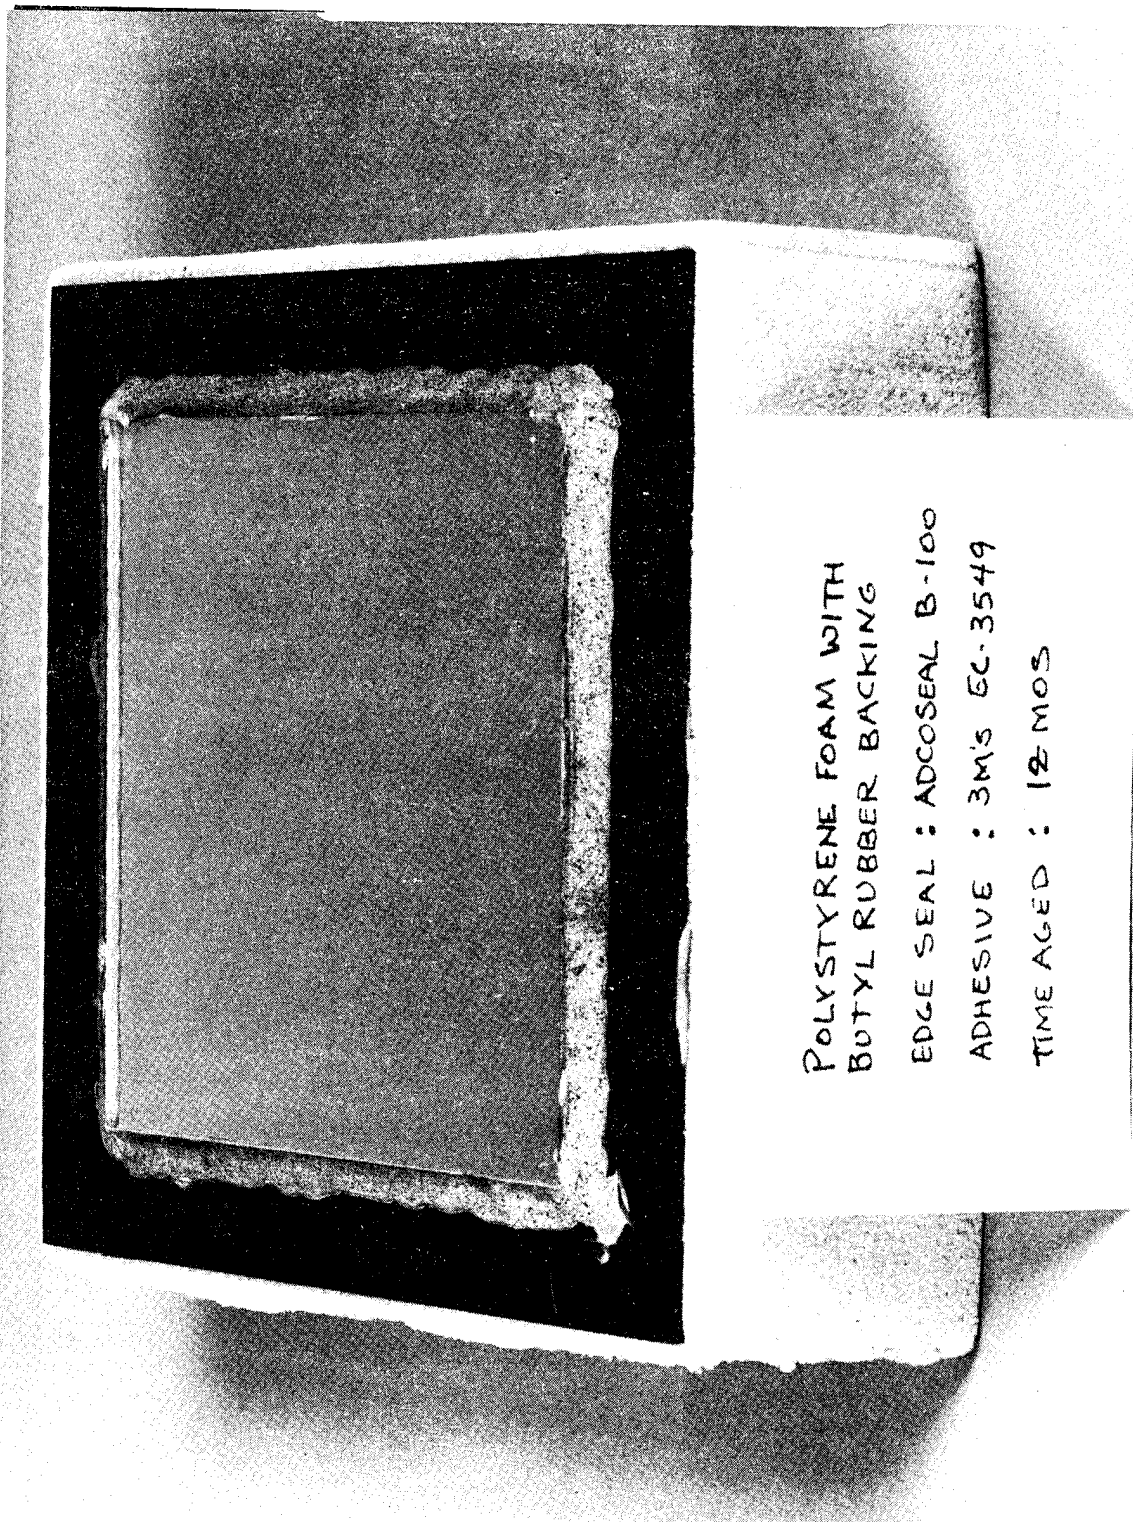
FIGURE 4

One of the better heliostat sealants was found to be a butyl rubber, Adcoseal B-100 (see Table 2 and Figure 4). This module incorporated a design modification; a 1/16" butyl rubber pad bonded between the mirror and the polystyrene foam substrate. The module looked extremely good after 12 months accelerated aging. A sealant of this type must be used with some degree of caution because butyl rubbers are not normally as thermally stable or UV resistant as silicones.

POLYSTYRENE FOAM WITH
BUTYL RUBBER BACKING
EDGE SEAL : ADCOSEAL B-100
ADHESIVE : 3M'S EC-3549
TIME AGED : 12 MOS

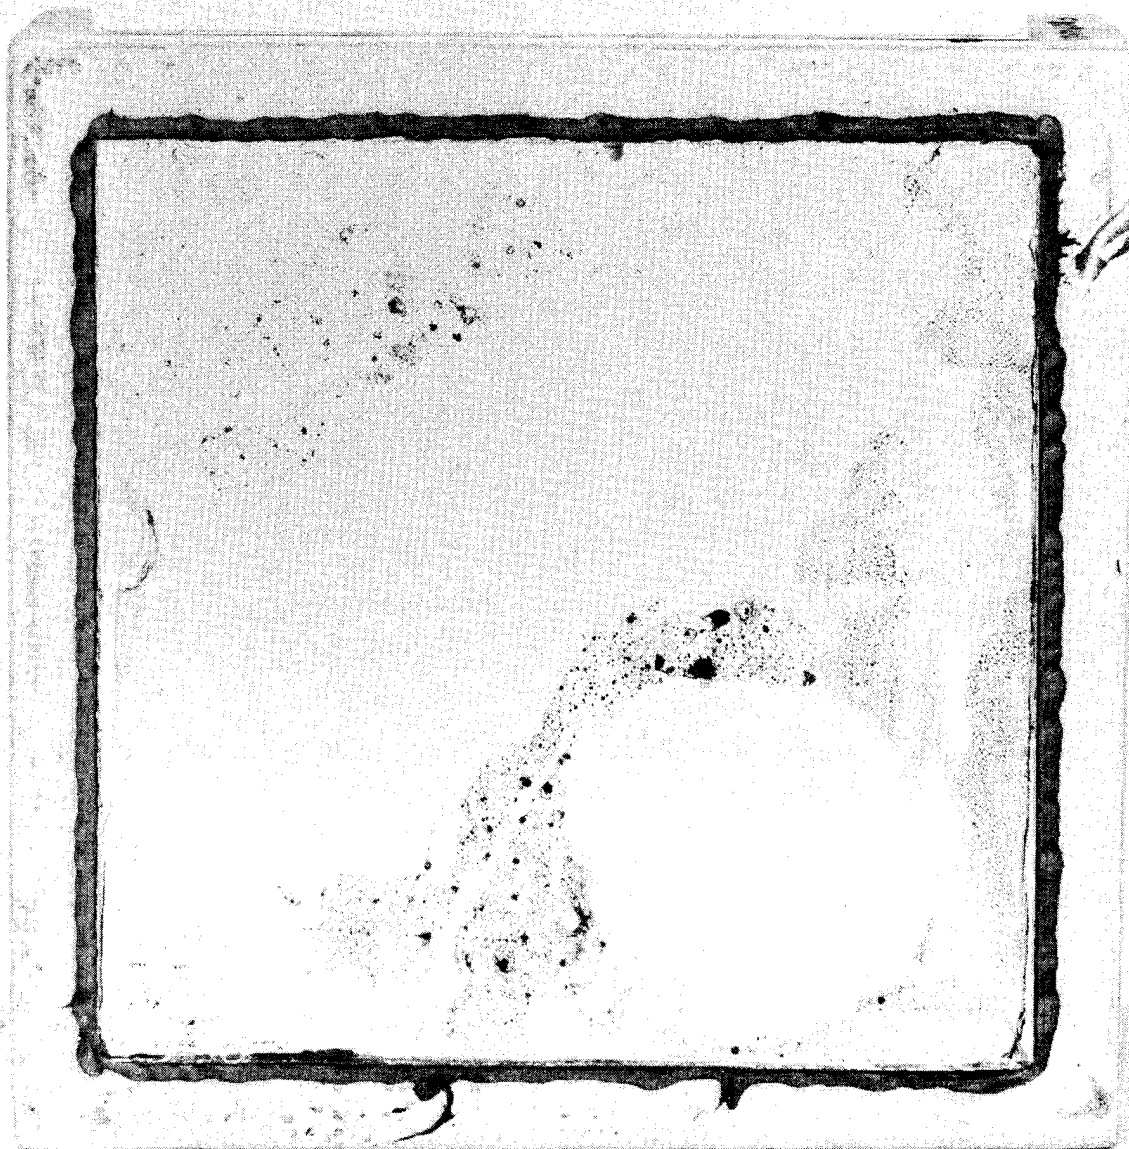
The paper honeycomb substrates sealed with either epoxy-fiberglass or melamine all showed some form of mirror degradation after 6 months and increased deterioration at 12 months (see Table 3 and Figures 5 and 10). The same explanation for the degradation in the polystyrene modules apply to this test design. Post-mortem examination of some of the modules again showed areas of poor bonding which resulted in moisture pathways and subsequent mirror corrosion. It is virtually impossible to apply a uniform adhesive layer over a large surface and obtain a void free glue line. Thus, with the sandwich heliostat structures being evaluated for solar applications, void free glue lines will always present a problem. Furthermore, it was interesting to note the fingerprints on various mirror samples (e.g., Figure 5). These fingerprints must have happened during mirror manufacture, since the mirrors contained the protective gray paint prior to our assembling the modules. Fingerprints prevent good silver to glass bonding and create degradation sites.

FIBERGLASS FACE

PAPER HONEYCOMB BODY

ADHESIVE : 3M's EC-3549

EDGE SEAL : DOW CORNING 790 SEALANT

TIME AGED : 12 mos.

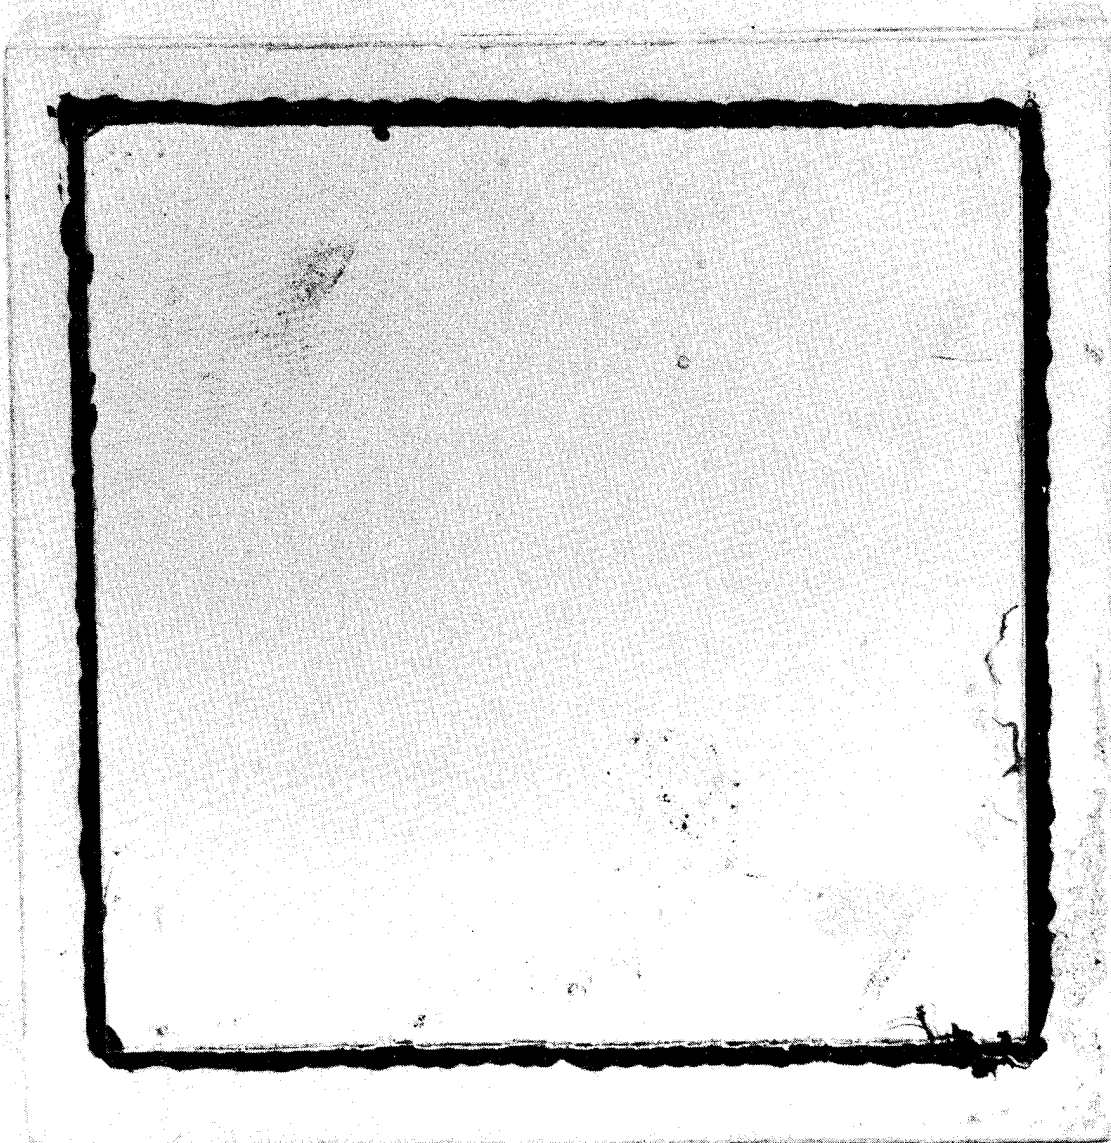
FIGURE 7

FIBERGLASS FACE
PAPER HONEYCOMB BODY
ADHESIVE : 3M's EC-3549
EDGE SEAL : GE 1200 CONSTRUCTION SEALANT
TIME AGED : 12 mos.

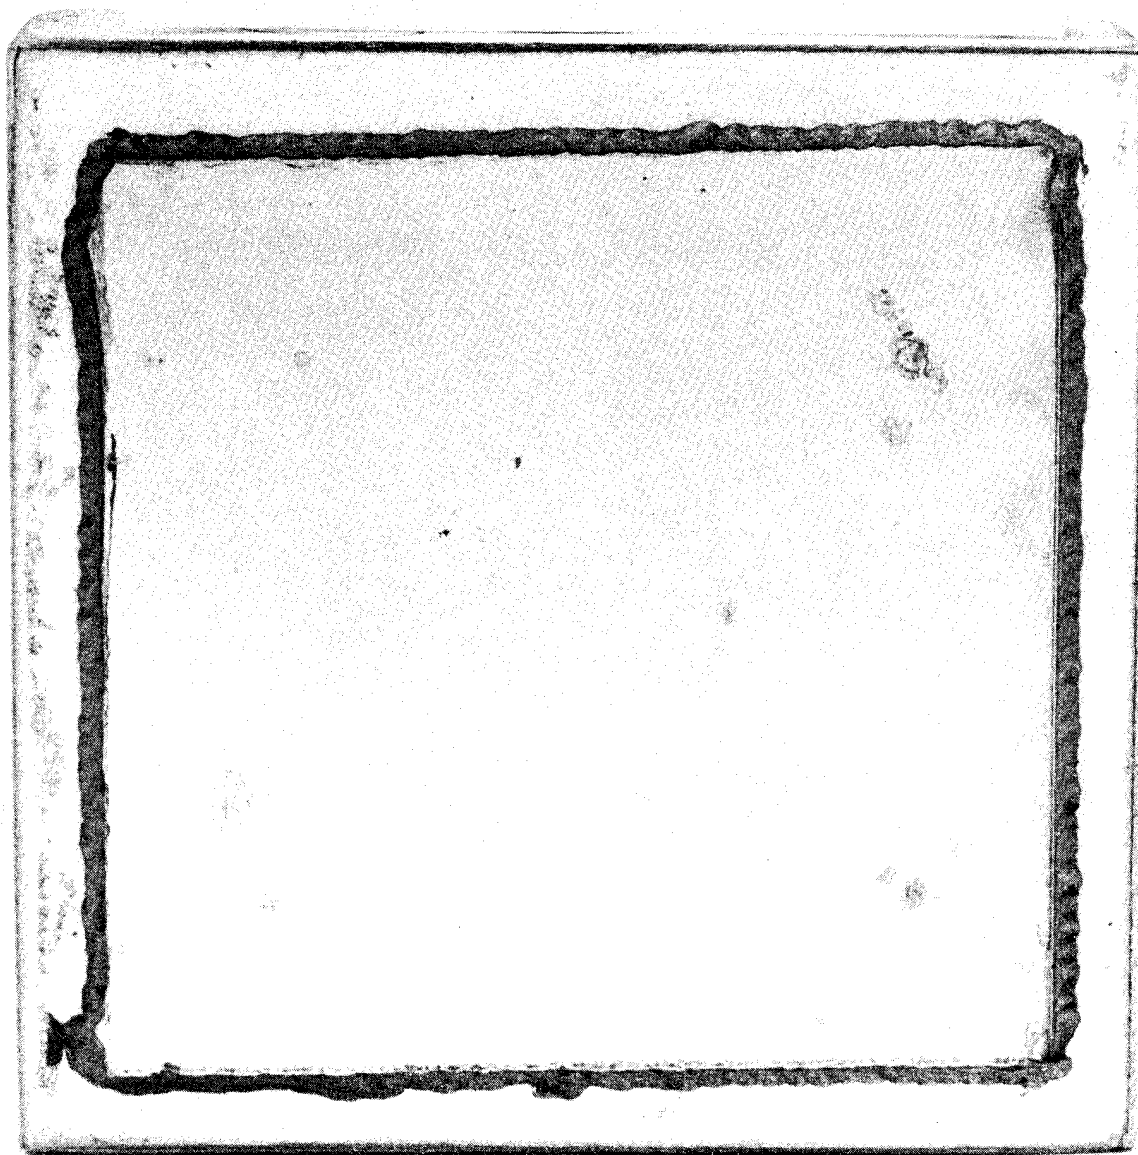
FIGURE 8

MELAMINE FACE
PAPER HONEYCOMB BODY

ADHESIVE : 3M's EC- 3549
EDGE SEAL : DOW CORNING 790 SEALANT
TIME AGED : 12 mos.

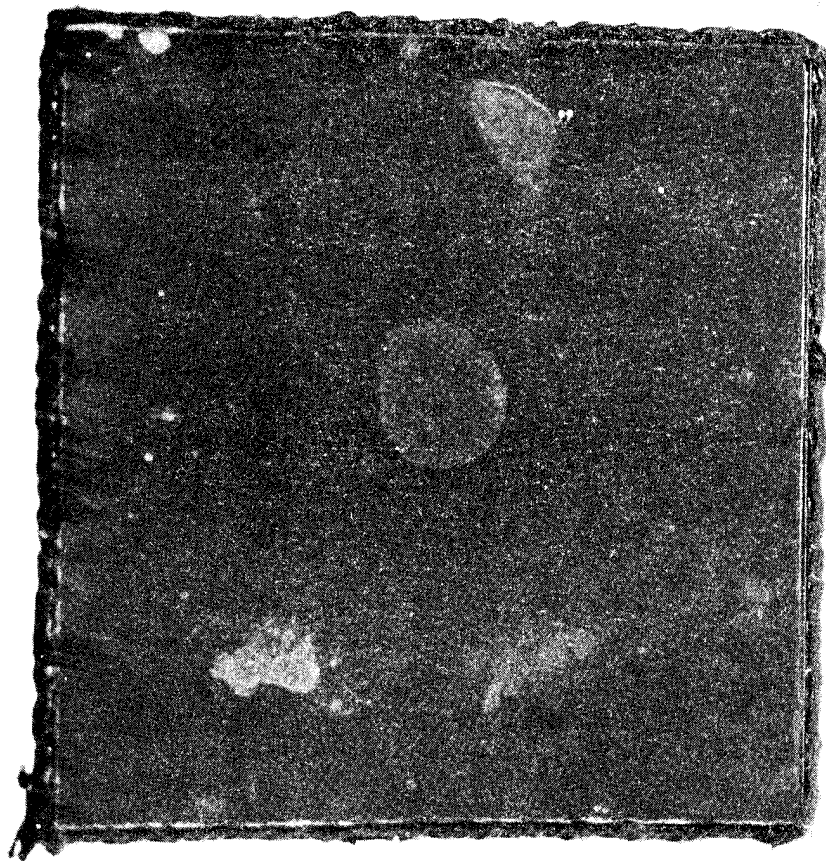
FIGURE 10

MELAMINE FACE
PAPER HONEYCOMB BODY

ADHESIVE : 3M's EC- 3549
EDGE SEAL : GE 1200 CONSTRUCTION SEALANT
TIME AGED : 12 mos.

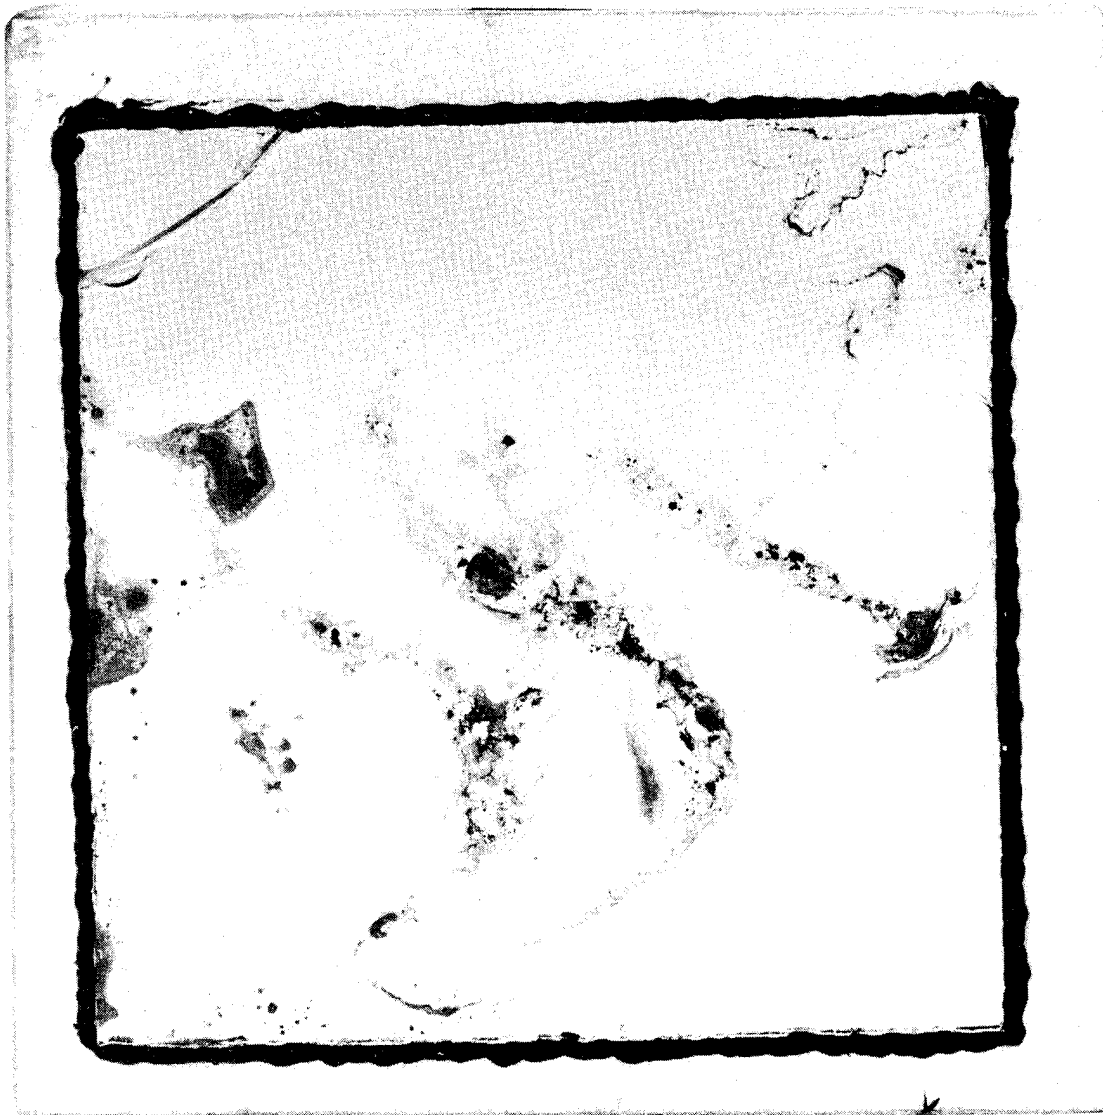
FIGURE 11

The sine wave fiberglass substrates sealed with either epoxy-fiberglass or melamine exhibited mirror deterioration after 6 months with increased degradation at 12 months (see Table 4 and Figures 11-16). Figures 11 and 15 are samples in which accidental impacts led to cracks. No deterioration was noted around the crack shown in Figure 11, whereas the sample in Figure 15 exhibited considerable pitting along the crack edges. In the first instance the bonding integrity of the silver and gray paint must still be substantial to preclude any silver degradation. In the latter sample, the bonding must have been weakened from the impact resulting in degradation. Post-mortem examination of the modules shown in Figures 11 and 12 dramatizes the degradation effects attributed to thermal expansion mismatches in sandwich heliostat structures. The sine wave ribs are perpendicular to the mirror surface and work against the mirror during thermal cycling causing debonding in the immediate contact area. This phenomenon provides a pathway for moisture to enter. Notice how the corrosion pattern replicates the sine wave structure. Mirror longevity is just as much a function of heliostat design as is material selection.

FIBERGLASS FACE
SINE WAVE FIBERGLASS BODY
ADHESIVE : 3M's EC- 3549
EDGE SEAL : GE 1200 CONSTRUCTION SEALANT
TIME AGED : 12 mos.

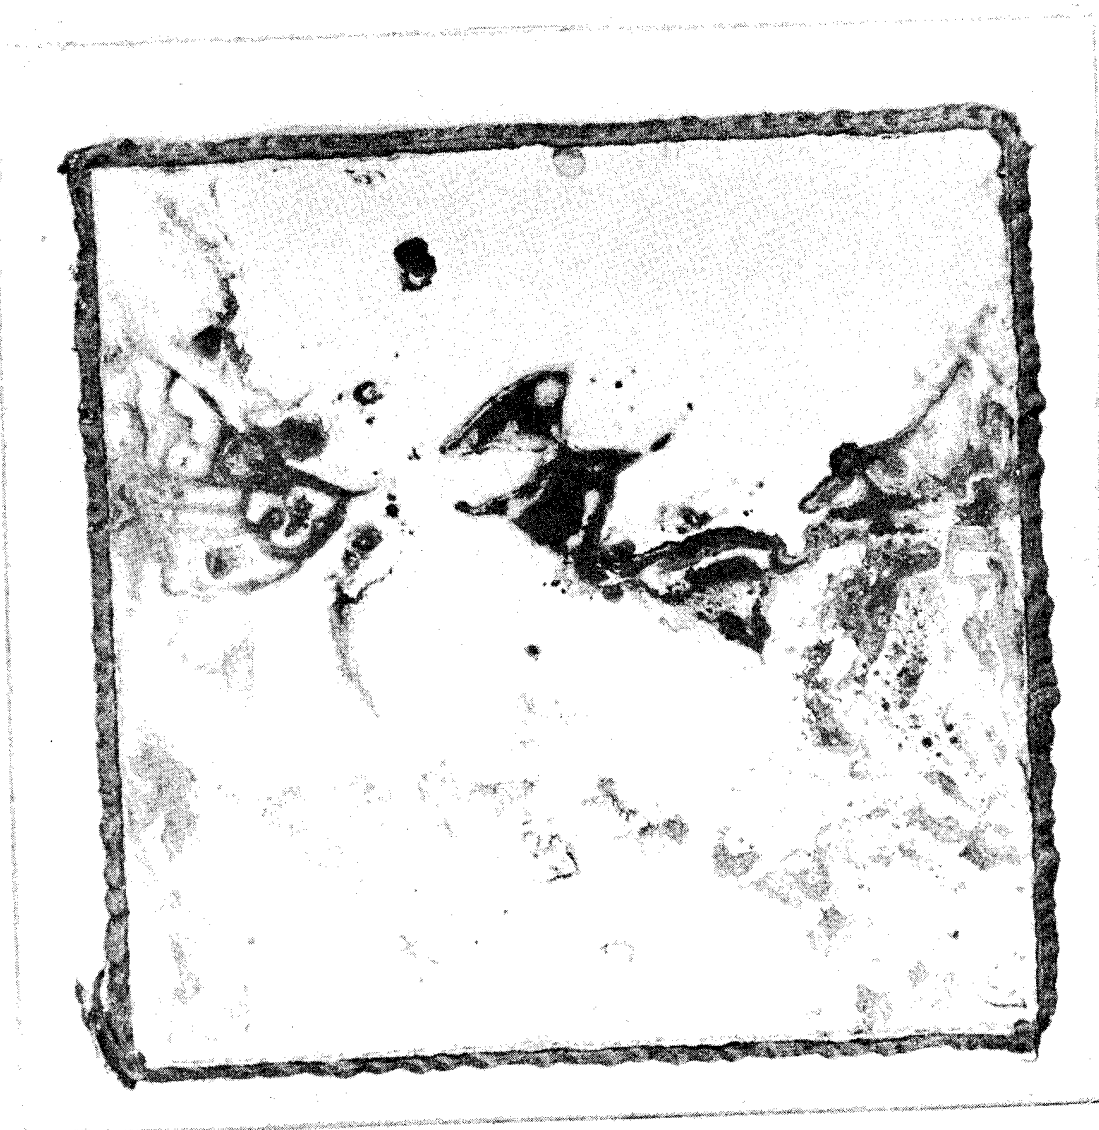
FIGURE 13

FIBERGLASS FACE
SINE WAVE FIBERGLASS BODY

ADHESIVE : 3M's EC- 3549
EDGE SEAL : DOW CORNING 790 SEALANT
TIME AGED : 12 mos.

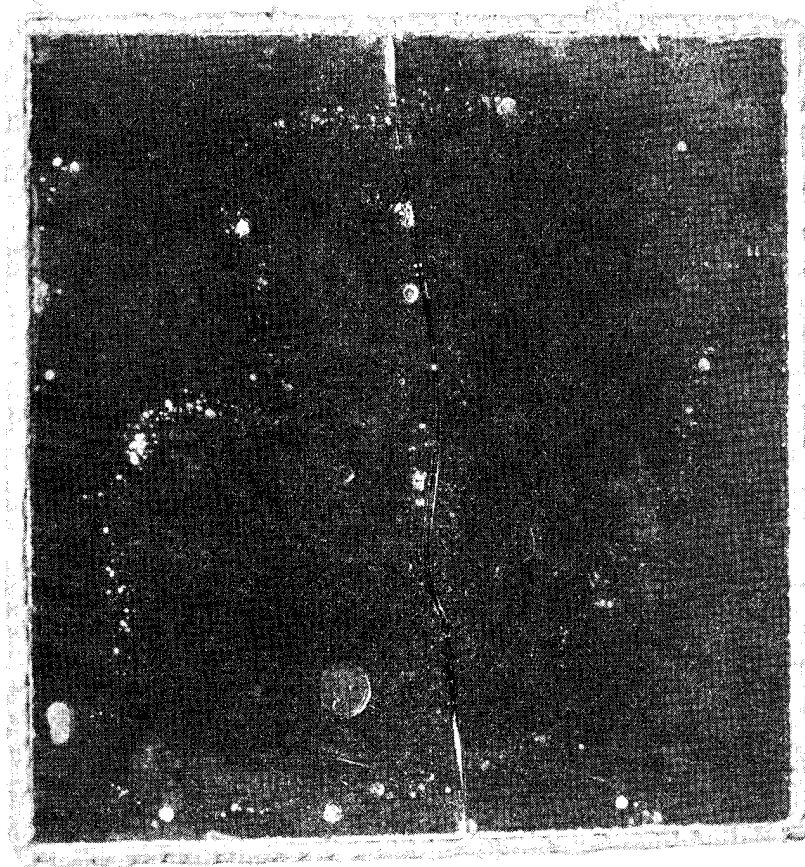
FIGURE 15

MELAMINE FACE
SINE WAVE FIBERGLASS BODY

ADHESIVE : 3M's EC- 3549
EDGE SEAL : DOW CORNING 790 SEALANT
TIME AGED : 12 mos.

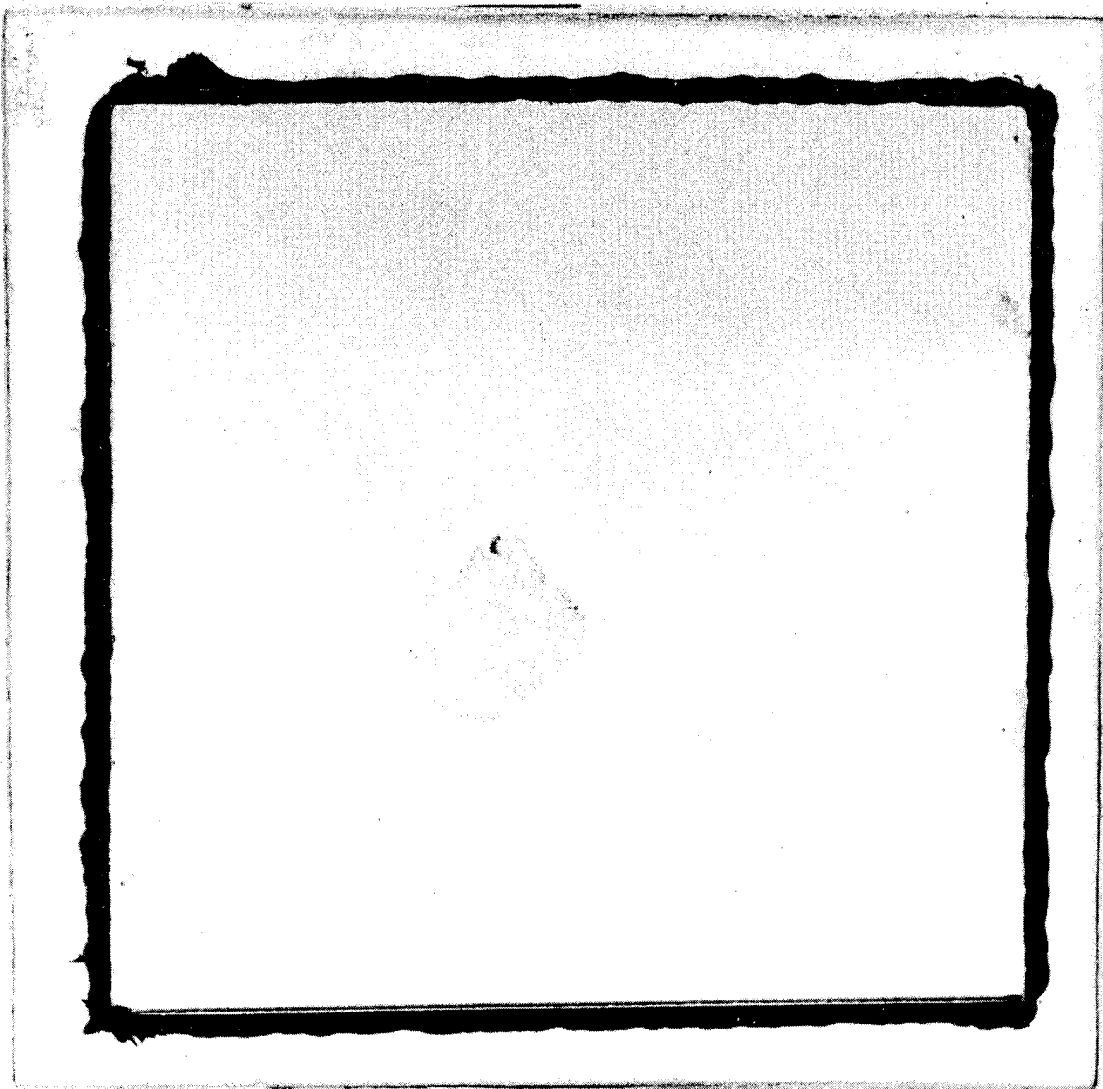
FIGURE 16

MELAMINE FACE
SINE WAVE FIBERGLASS BODY

ADHESIVE : 3M's EC- 3549
EDGE SEAL : GE 1200 CONSTRUCTION SEALANT
TIME AGED : 12 mos.

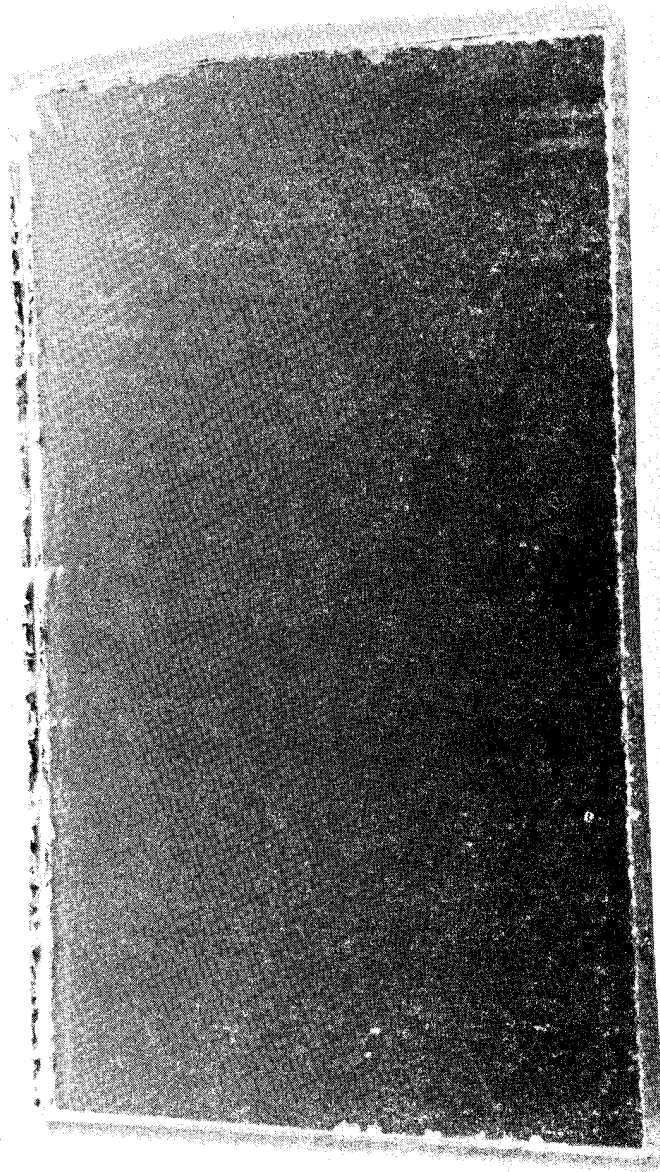
Observe the two control samples that were included in the aging study (see Table 3 and Figures 15-16). The Gardner mirror without any protection showed only a slight amount of pitting after 12 months. Survival of this mirror with a minimal amount of damage was attributed to its ability to "breathe". Moisture was not trapped as postulated in the

PLAIN MIRROR

NO EDGE SEAL

NO BACKING

TIME AGED: 14 MOS

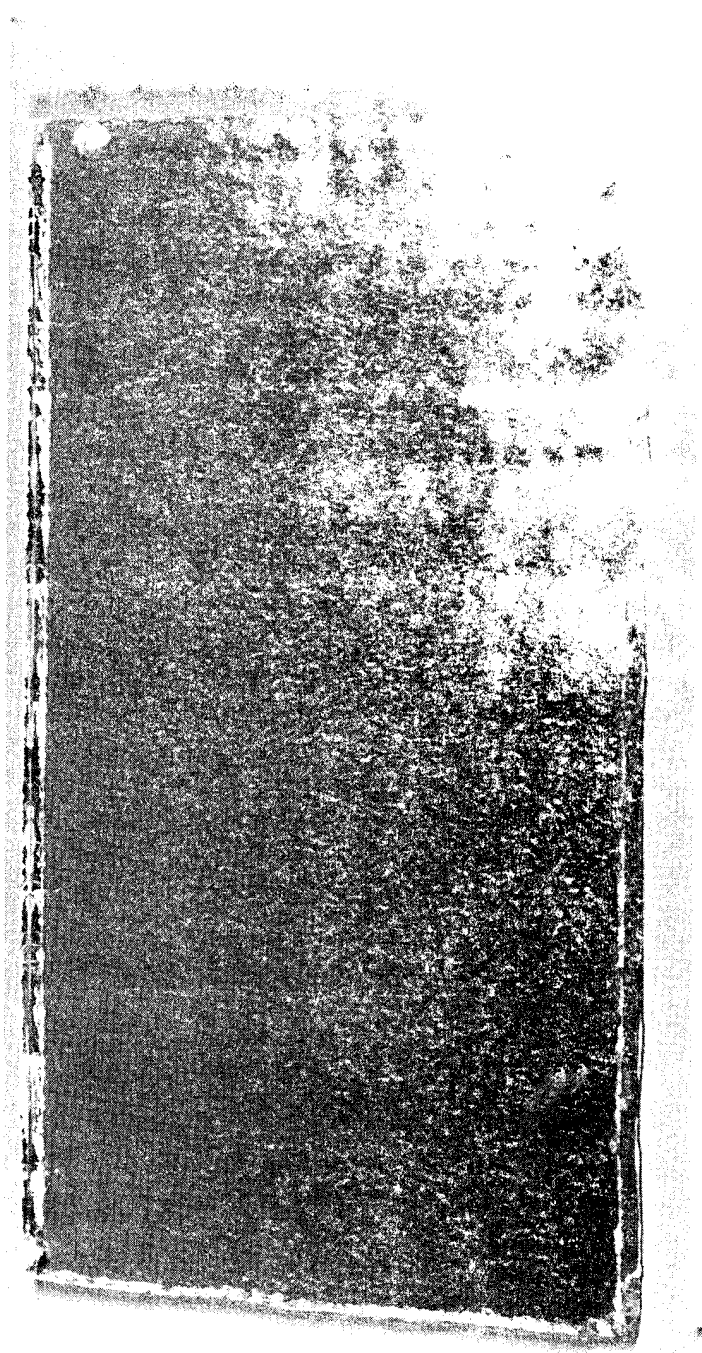
other composite heliostat designs. The control which was coated with the adhesive, EC-3549, showed evidence of deterioration (spotting, shadows) after 6 months. This corrosion suggests incompatibility between the adhesive and silver. The EC-3549 is a polyurethane adhesive cured with an amine. According to a literature source (8), the basicity of an amine in the presence of moisture can result in silver deterioration. Therefore, we could not really evaluate the effectiveness of the respective edge seals because material incompatibilities, nebulous bonding and heliostat designs appeared to have a greater bias on the results than edge seal selection.

PLAIN MIRROR

NO EDGE SEAL

ADHESIVE : 3M'S EC-3549

TIME AGED : 14 MOS
